Smoke and Dye Testing Summary

High Level Sewershed

Run Summary

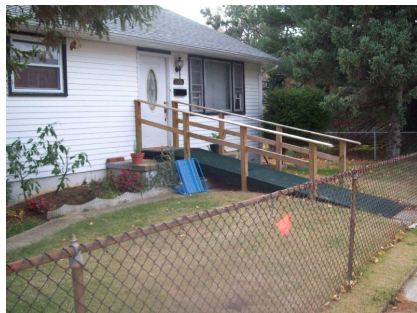
Picture \S1028-140-OB01-P01.jpg

Comments Smoke from cleanout in front yard. 2701 Spaulding Ave.

Comments Front of house, 2701 Spaulding Ave.

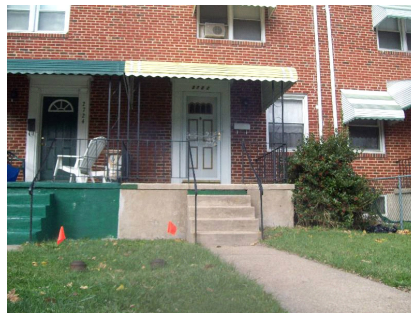
Picture \S1028-140-OB02-P01.jpg

Comments Smoke from cleanout in front yard. 2722 Spaulding Ave.

Comments Smoke indicated by flag on the right. Front of house, 2722 Spaulding Ave.

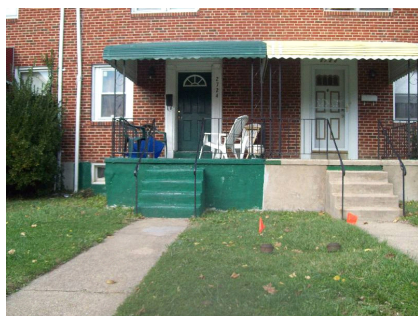
Picture \S1028-140-OB03-P01.jpg

Comments Smoke from cleanout in front yard. 2724 Spaulding Ave.

Comments Smoke indicated by flag on the left. Front of house, 2724 Spaulding Ave.

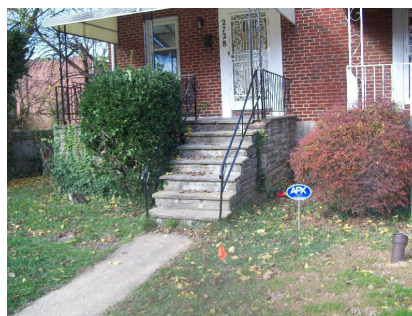
Picture \S1028-140-OB04-P01.jpg

Comments Smoke from cleanout in front yard. 2728 Spaulding Ave.

Comments Front of house, 2728 Spaulding Ave.

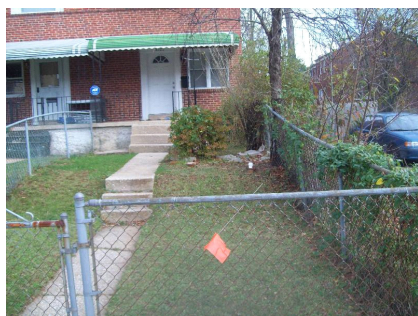
Picture \S1028-140-OB05-P01.jpg

Comments Smoke from cleanout in front yard. 5101 Pimlico Rd.

Comments Front of house, 5101 Pimlico Rd.

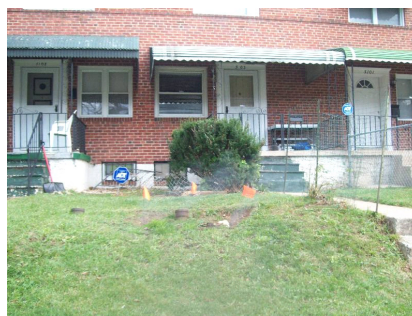
Picture \S1028-140-OB06-P01.jpg

Comments Smoke from cleanout in front yard. 5103 Pimlico Rd.

Comments Smoke indicated by middle flag. Front of house, 5103 Pimlico Rd.

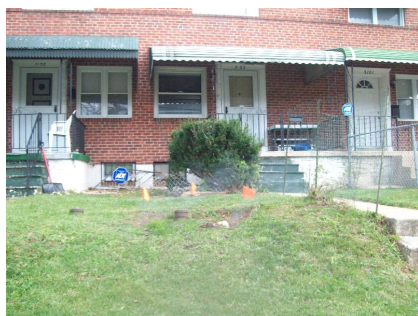
Picture \S1028-140-OB07-P01.jpg

Comments Smoke from service lateral in front yard next to cleanout. 5103 Pimlico Rd.

Comments Smoke indicated by flag on left. Front of house, 5103 Pimlico Rd.

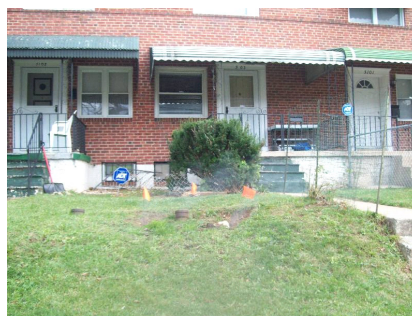
Picture \S1028-140-OB08-P01.jpg

Comments Smoke from service lateral in front yard under concrete next to cleanout. 5103 Pimlico Rd.

Comments Smoke indicated by flag on right. Front of house, 5103 Pimlico Rd.

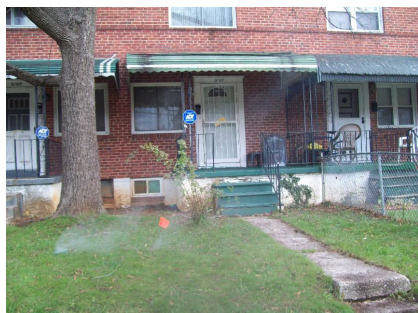
Picture \S1028-140-OB09-P01.jpg

Comments Smoke from cleanout in front yard. 5107 Pimlico Rd.

Comments Front of house, 5107 Pimlico Rd.

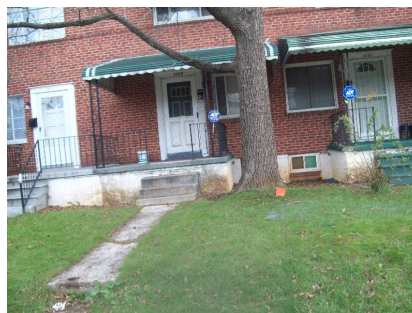
Picture \S1028-140-OB10-P01.jpg

Comments Smoke from cleanout in front yard. 5109 Pimlico Rd.

Comments Front of house, 5109 Pimlico Rd.

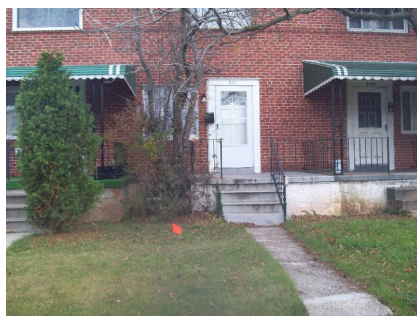
Picture \S1028-140-OB11-P01.jpg

Comments Smoke from cleanout in front yard. 5111 Pimlico Rd.

Comments Front of house, 5111 Pimlico Rd.
